Important updates to DV+ T9351

GFB Technical Bulletin: DV+ (part # T9351) leak issue: 9th September 2013.

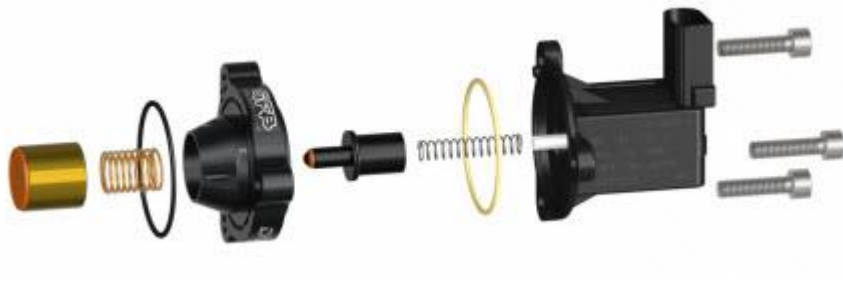
All new T9351 DV+ kits come with the new plunger (which can be identified by its black colour as opposed to the silver finish of the original plunger) and spring.

For the earlier DV+ T9351 models, all that is required is to replace the existing plunger and OE plunger spring with the parts supplied in the GFB upgrade kit.
